CANADIAN FORCES FLIGHT SAFETY INVESTIGATION REPORT

FINAL REPORT

FILE NUMBER: 1010-C-GCLR (DFS 2-4-2)
DATE OF REPORT: 12 October 2004
AIRCRAFT TYPE: SZ2-33
DATE/TIME: 20 Sep 2003, 1630L
LOCATION: Alexandria, Ontario
CATEGORY: "A" Category Accident

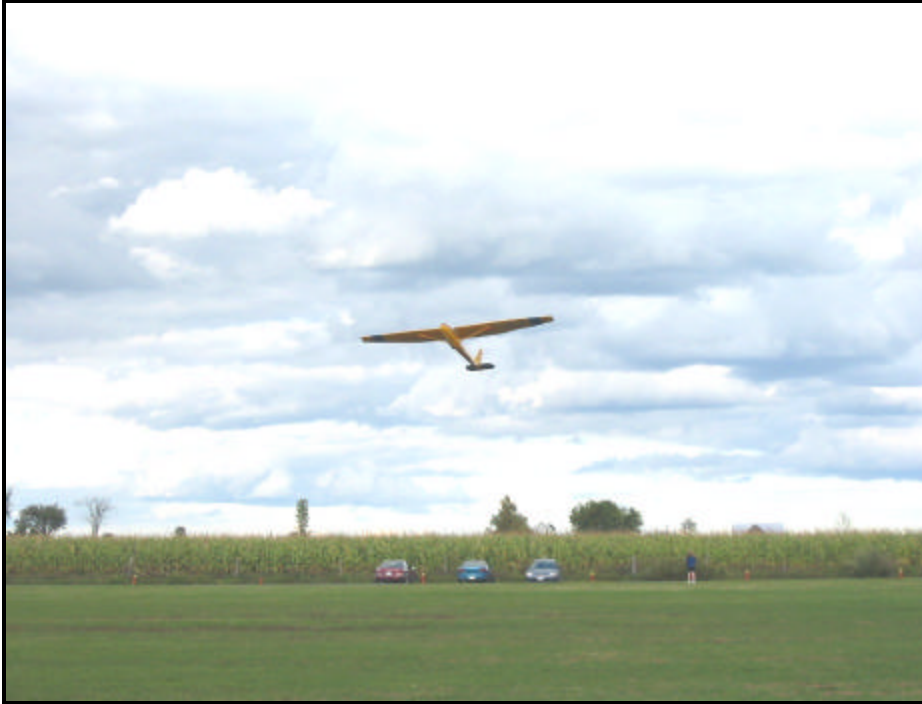
- 3.1.9 During the VRP the pilot failed to retract the spoilers and subsequently caused the glider to attain only 100' AGL during the climb instead of the anticipated 250'.

3.2.1.1 The pilot attempted to perform a prohibited manoeuvre, the Very Rapid Pull-up. During the manoeuvre, the pilot neglected to retract the spoilers at the bottom of the VRP and, as a result, the glider attained a height of 100' AGL instead of the anticipated 250' AGL.

Photo 1: Pilot begins the VRP with spoilers set to 100%.

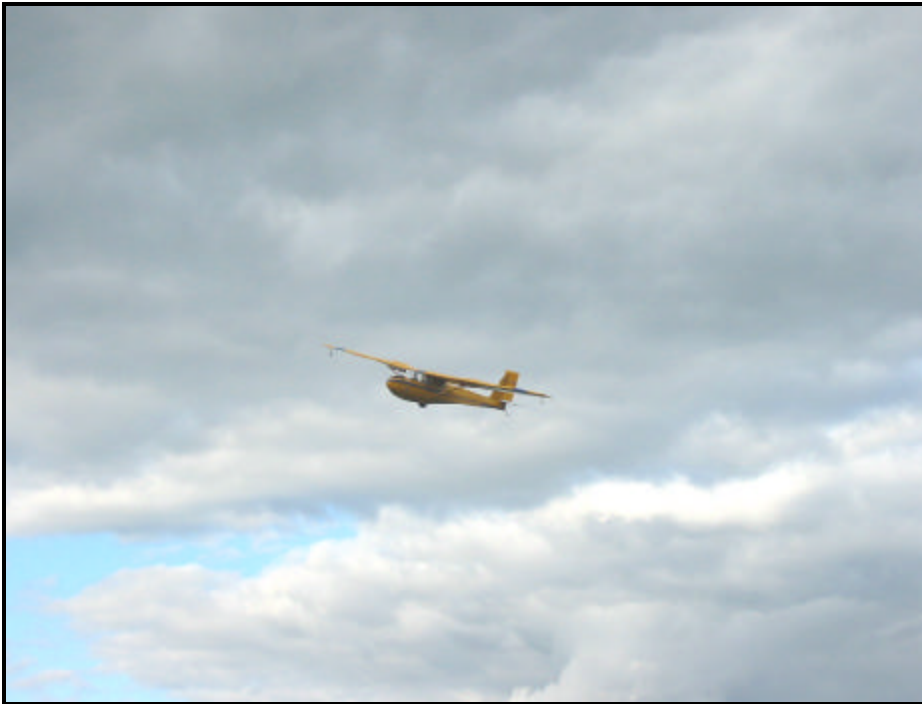
At 100' AGL and 50 MPH with the spoilers fully extended, the pilot used 45°-60° of bank in order to make the 90° heading change to line up on the auxiliary field. Approximately 3/4 of the way through this turn the left wingtip contacted the ground. The glider then cartwheeled through 180°, eventually coming to rest after about 200' of ground travel.

Photo 2: Glider is level at 100' AGL and starting to turn towards the Auxiliary field.

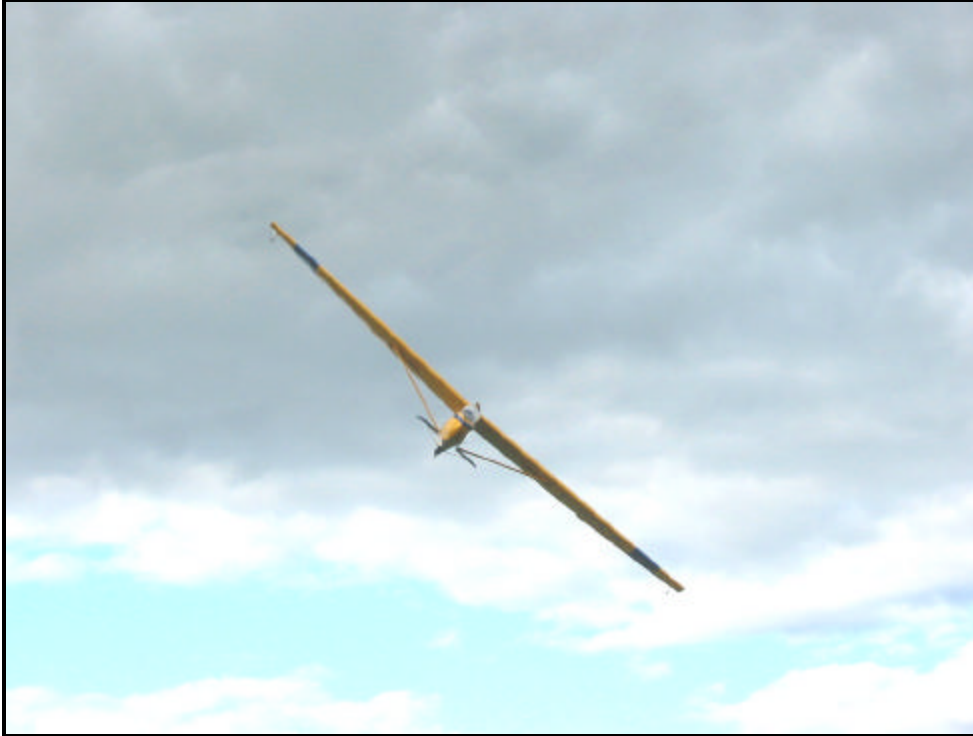
Photo 3: Glider is through approximately $\frac{1}{2}$ of the turn towards the Auxiliary field.

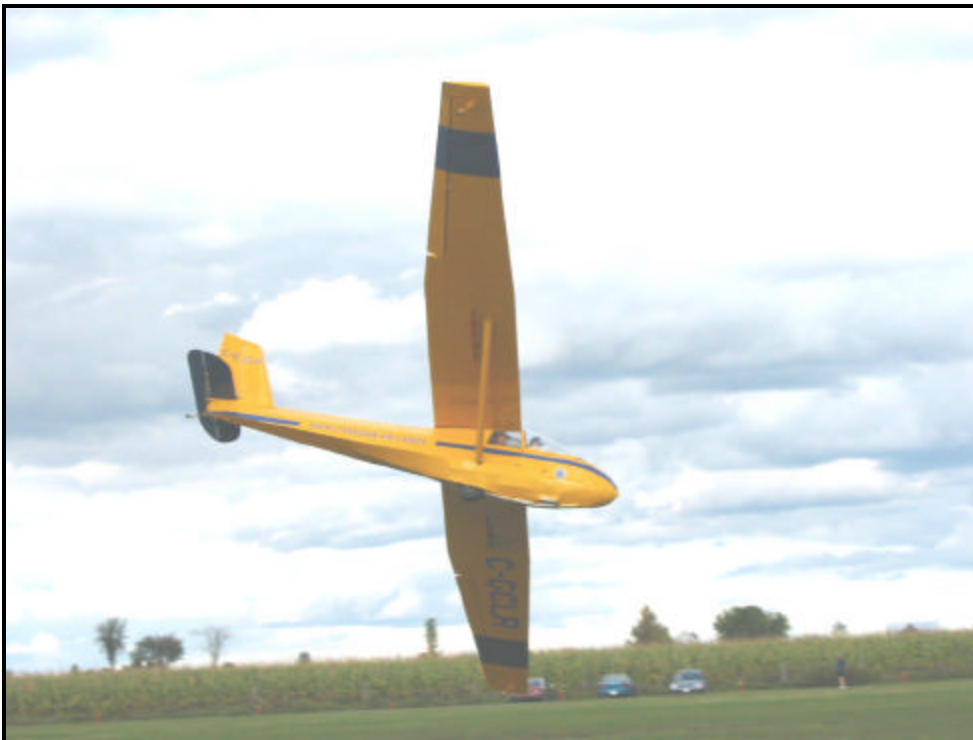
- 3.1.12 Despite the glider's close proximity to the ground, the pilot believed that he was capable of completing the turn.
- 3.1.13 The left wingtip contacted the ground approximately $\frac{3}{4}$ of the way through the turn to final, causing the glider to cartwheel and crash.

Photo 4: Left wingtip is approximately 5' AGL.

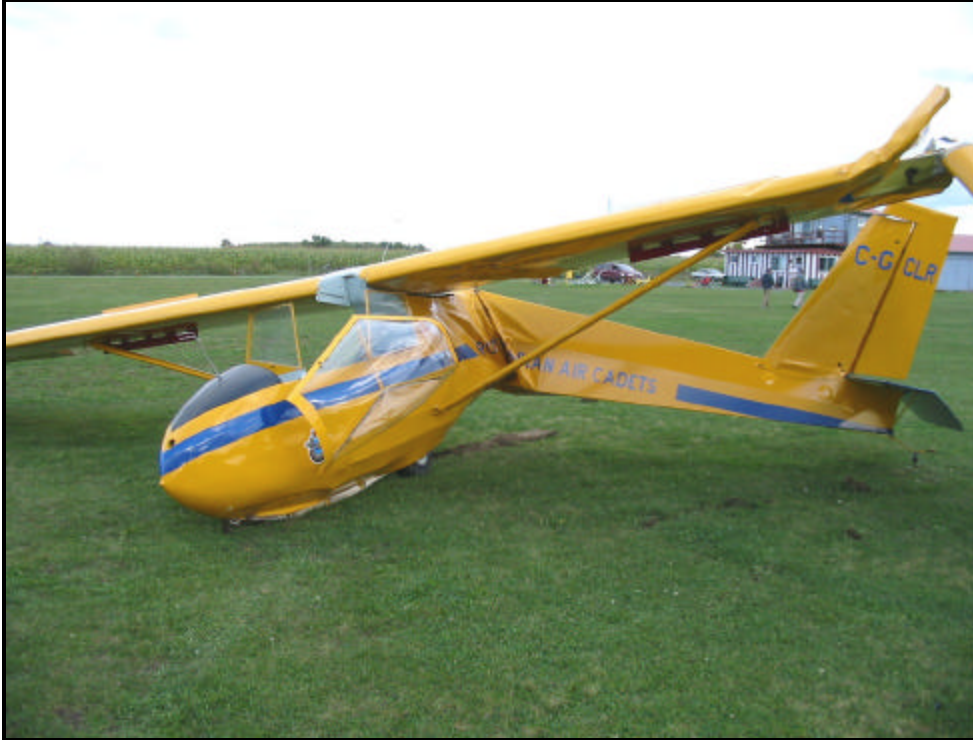
Photo 5: Gliding Centre members released the canopy from the outside.

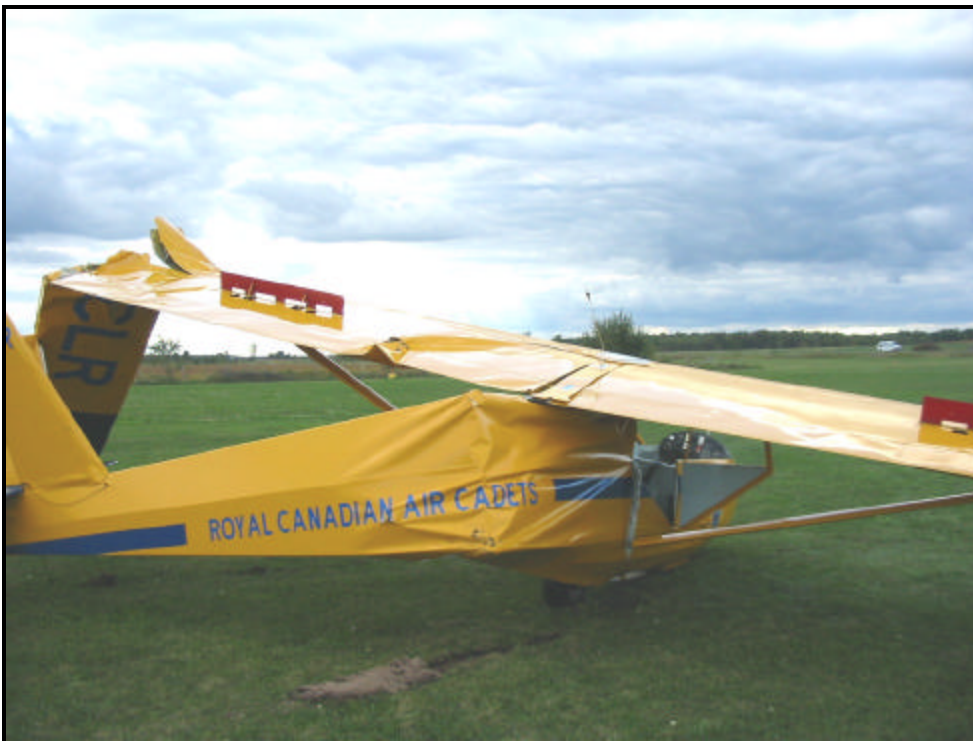
The pilot believed that he had in fact fully retracted the spoilers. Photographic evidence, both in-flight and post-crash, indicated otherwise. No definitive explanation could be found for this discrepancy. Possibly, due to his fixation with landing on the auxiliary field or his becoming task-saturated with the VRP manoeuvre, the pilot believed he had retracted the spoilers.

Photo 6: Note that the spoilers are fully extended.
